Concrete Bridge Design and Construction series

No. 12: Management of concrete bridges

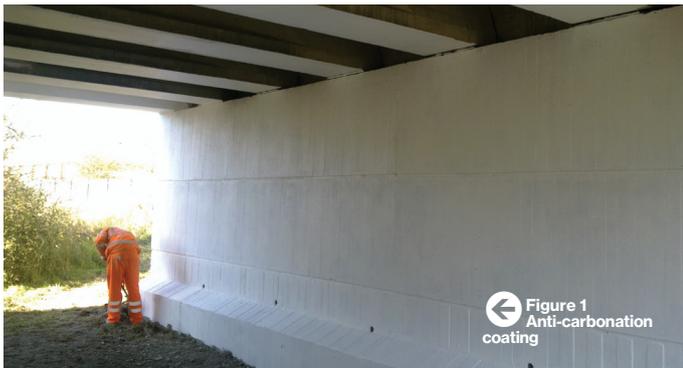
Figure 1
Anti-carbonation coating

Anti-carbonation coatings are available; these can be sprayed or applied with a brush to form a protective barrier (Figure 1). Maintenance of the coating should be included in the bridge maintenance plan. In addition to the coating, a migrating corrosion inhibitor (MCI) can be installed. These act by suppressing the electrochemical corrosion reactions that may occur on the surface of reinforcing bars³. The MCI is usually applied by brush or sprayed onto the surface of the concrete (Figure 2). Due to their migrating properties, MCIs are able to penetrate the concrete to protect the steel reinforcement from chloride attack. Other versions are available in tablet form; these can be placed in holes drilled at regular centres in the concrete.

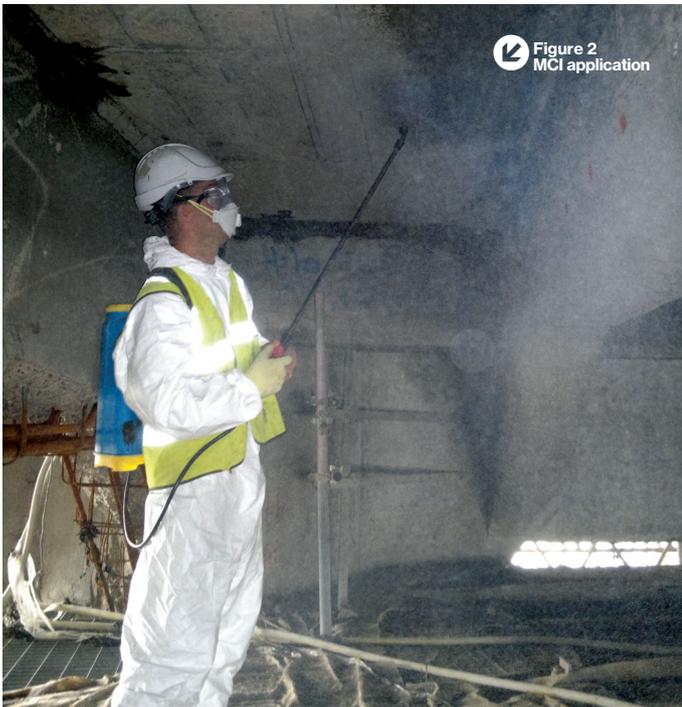
Figure 2
MCI application

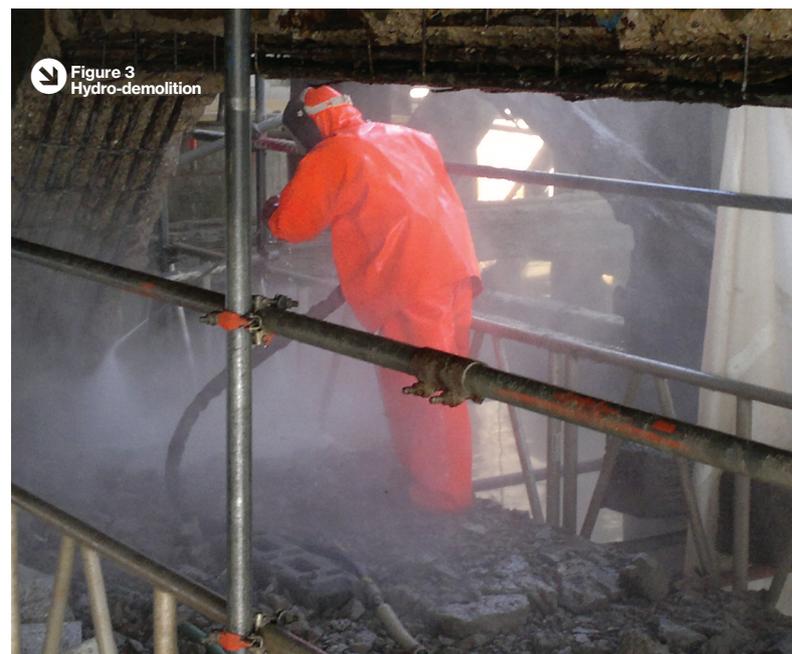
Figure 3
Hydro-demolition

The extent of repair will depend on the extent of chloride contamination and the condition of the reinforcement. Chloride-contaminated concrete will need to be removed, usually by hydro-demolition (Figure 3), which reduces the risk of damage to reinforcement and to concrete being retained (Figure 4). Reinforcement may also need to be replaced or supplemented, depending on the amount of section loss and structural capacity.

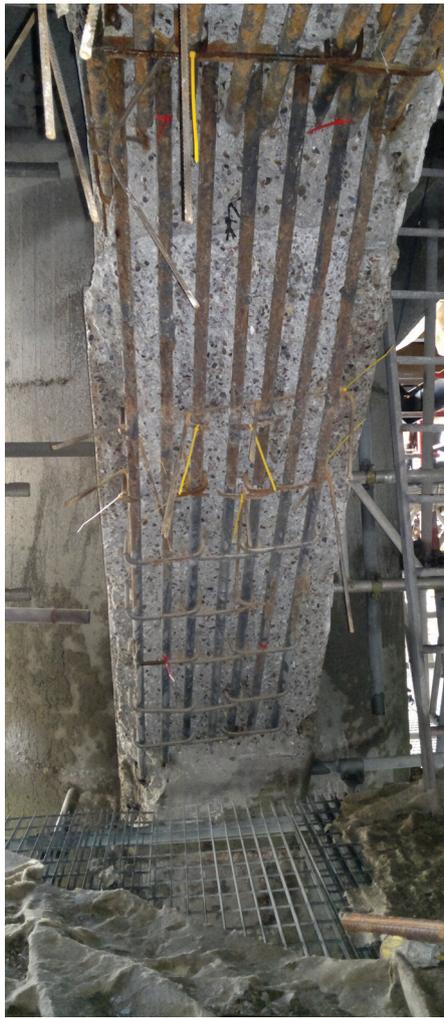
Figure 4
Exposed reinforcement after hydro-demolition

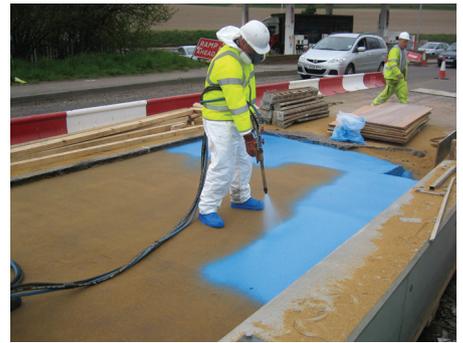
Figure 5
Application of waterproofing membrane

Concrete behind the reinforcement bars must be removed to ensure that the embedded chloride is eradicated and that the new concrete – whether sprayed, poured or hand-placed – has a key around the bars. Care must be taken if spraying, as voids can form in the shadow of reinforcement. It is essential that the source of chlorides is removed in locations such as bearing shelves; movement joints will often need to be replaced. Deck waterproofing will prevent ingress of chlorides and is a requirement on all new bridge decks in the UK (Figure 5). It is good practice to apply a red sand carpet over the waterproofing membrane to alert any future surfacing operations to its presence (Figure 6).

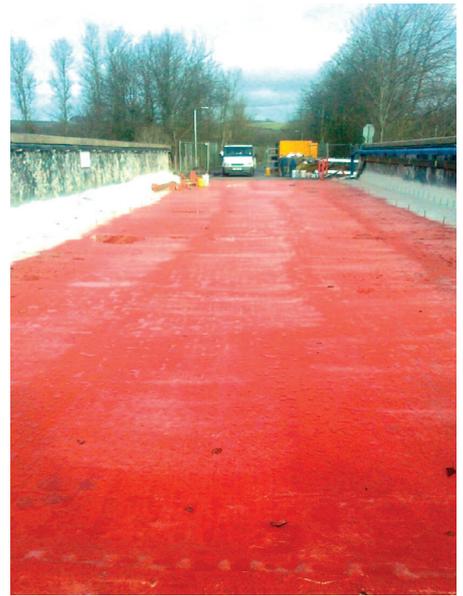
Figure 6
Red sand carpet over waterproofing

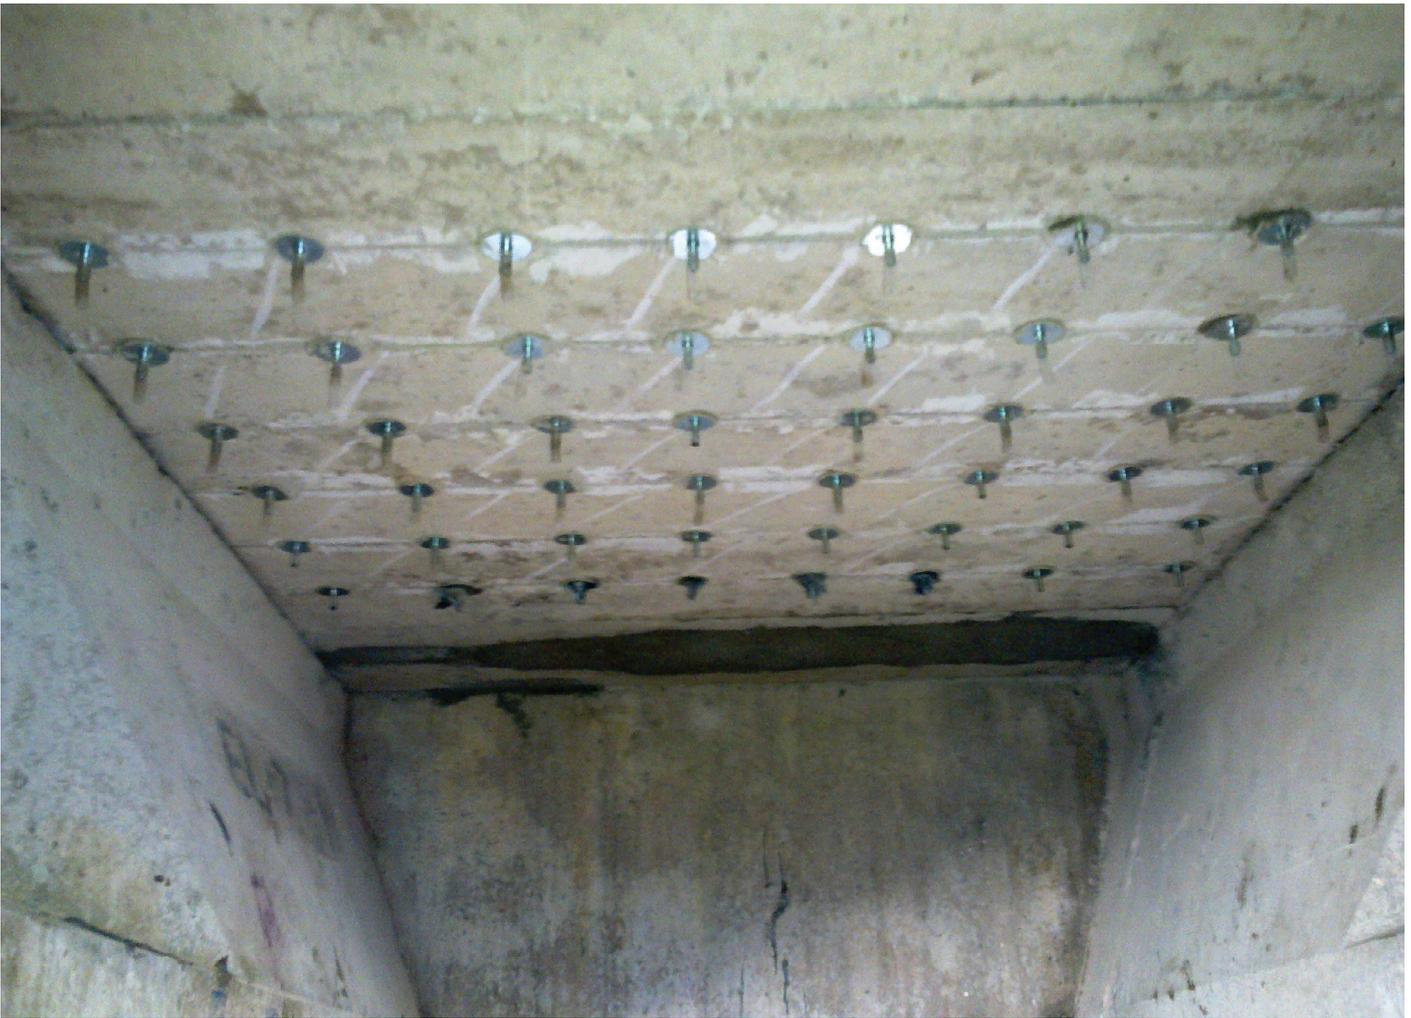
Figure 7
Resin injection

If the majority of the structure is sound, various repair techniques are available. This applies to all areas of deterioration, not only damage. The affected concrete should be removed by percussive methods or hydro-demolition. Resin injection can be used for sealing cracks (Figure 7). Exposed reinforcement can be assessed for loss of area and either re-used or replaced. New concrete can be cast *in situ* or sprayed (Figures 8 and 9). Other treatments, as described previously, can then be applied as required.

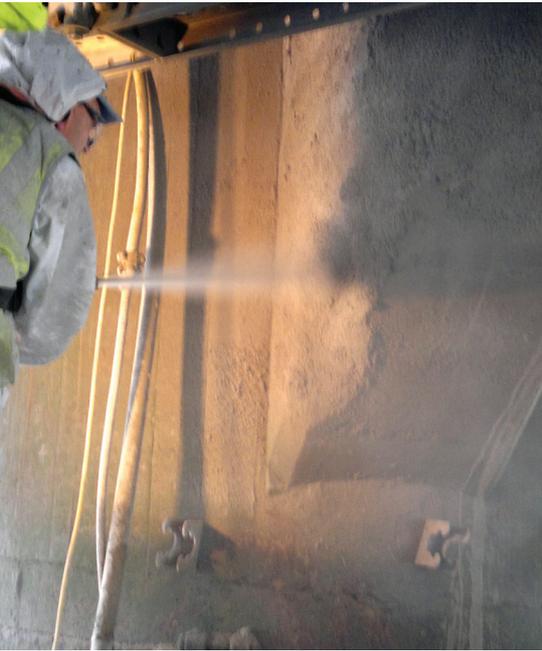
Figure 8
Application of sprayed concrete

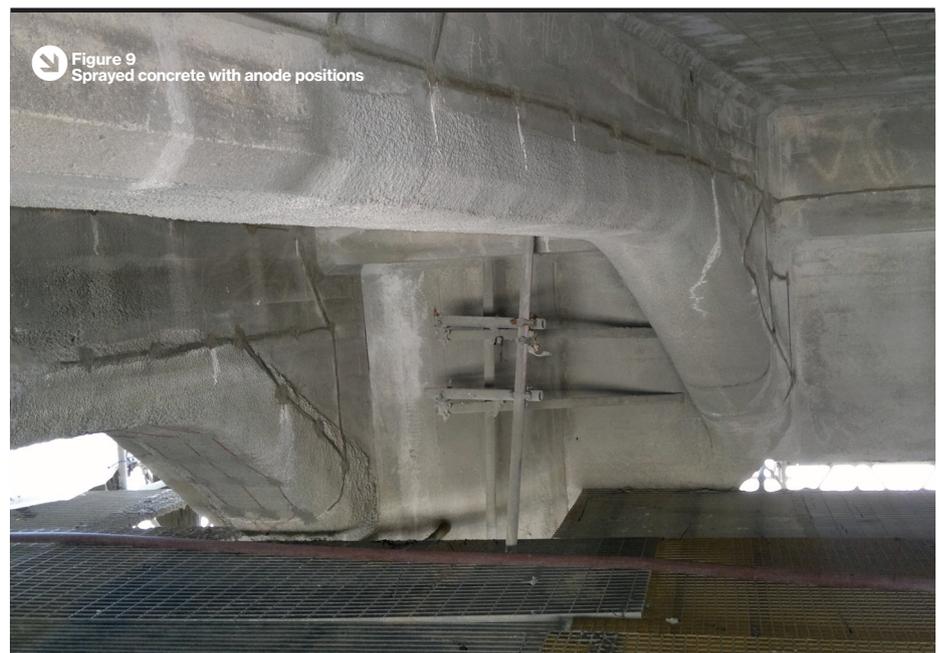
Figure 9
Sprayed concrete with anode positions
